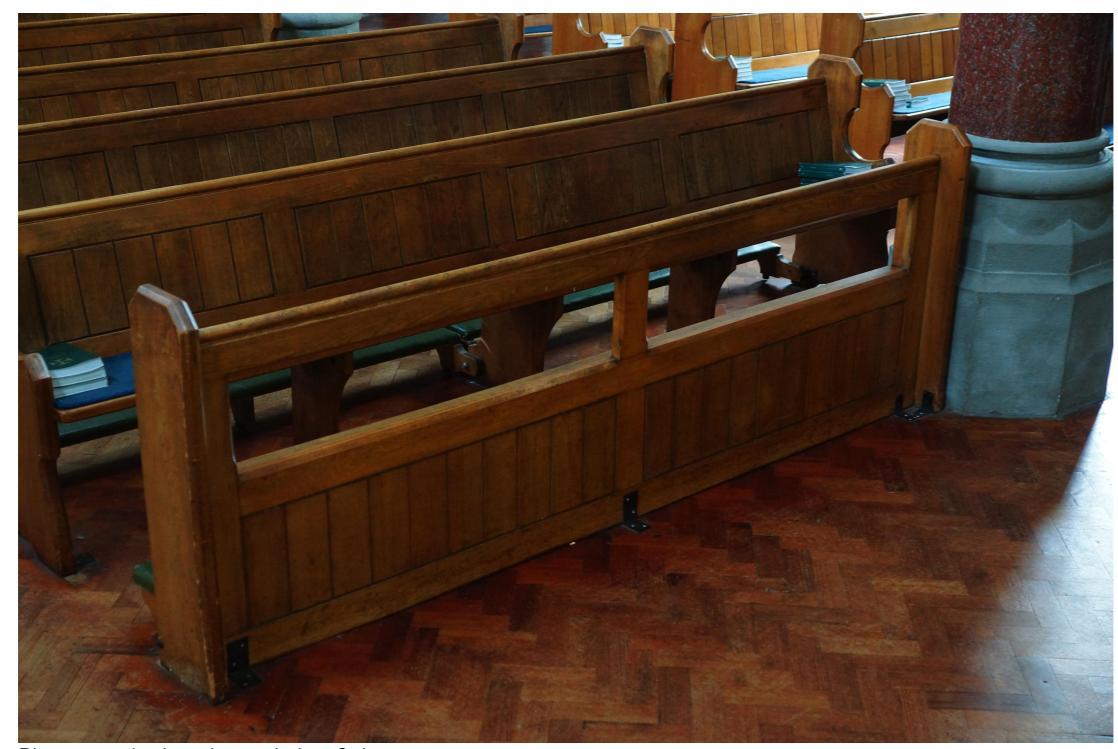
Photograph showing existing fixings

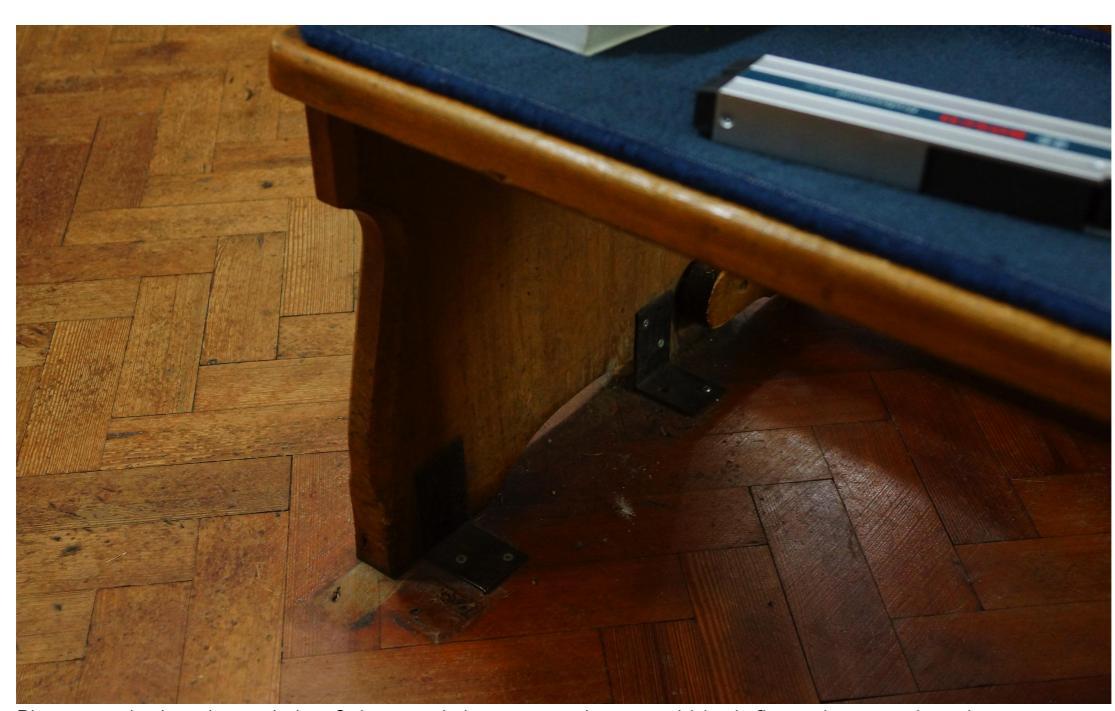
Photograph showing existing fixings and damage to the wood block floor due to relocation
